NASA Technical Memorandum 83786

## Fracture Surface Characteristics of Notched Angleplied Graphite/Epoxy Composites

Carol A. Ginty and Thomas B. Irvine  
*Lewis Research Center  
Cleveland, Ohio*

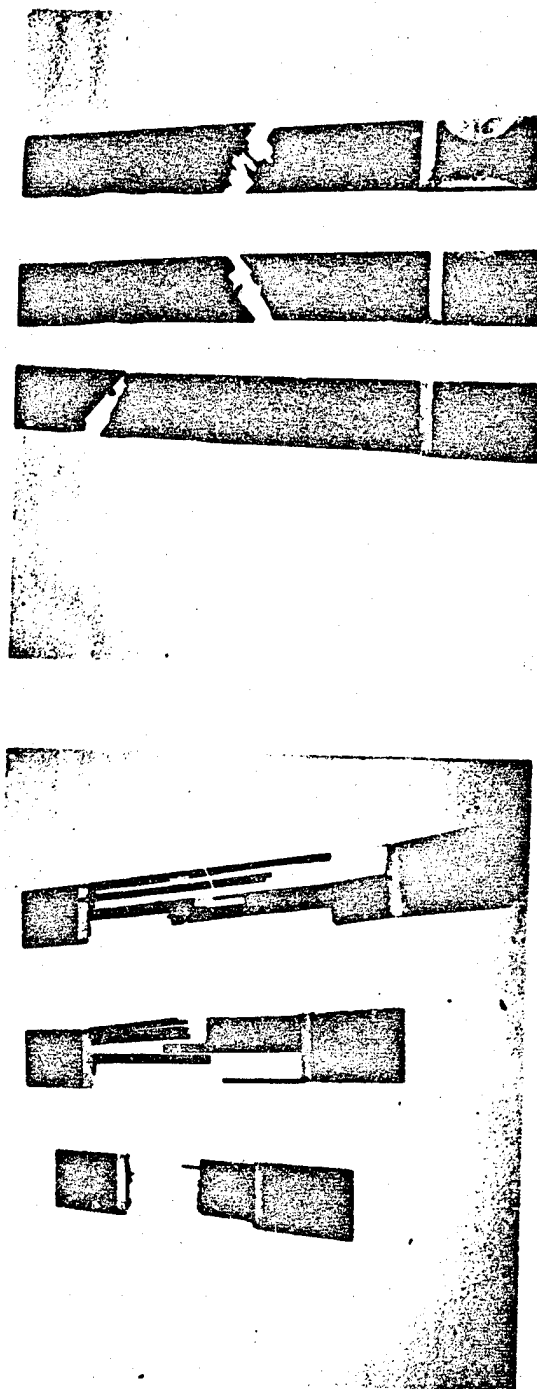
Uniaxial tension testing of the specimens was conducted in an incremental load-to-fracture manner using a 50 kip load frame with a prescribed load increment size. Fracture was catastrophic for the lower angle ( $0^\circ$  to  $15^\circ$ ) G/E specimens leaving very little of the composite intact (fig. 1(a)). The remaining angleplied specimens ( $30^\circ$  to  $90^\circ$ ) exhibited a brittle fracture process that produced puzzle-like pieces of the composite as the specimens broke apart (fig. 1(b)). Table I lists the fracture loads of the solid and notched specimens for each laminate configuration in the series.

Figure 1. - Fractured G/E specimens from left to right -- solid, notch/slit and notch/hole.

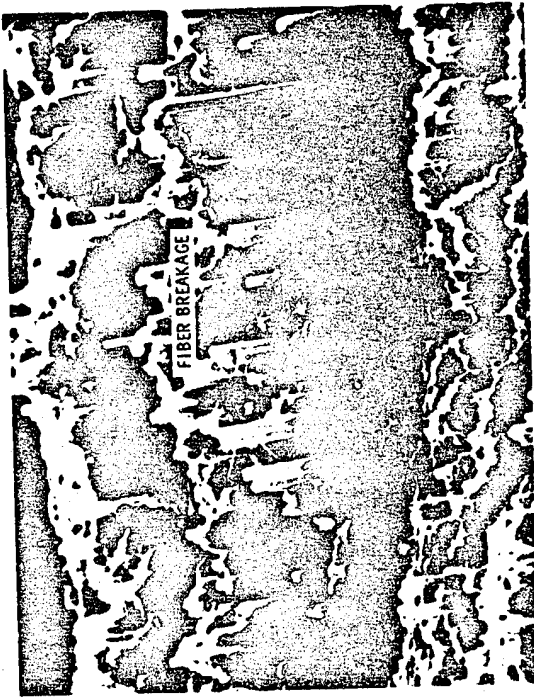
(b) 240X

At greater magnifications (figs. 2(b) and (c)) a characteristic associated with an intraply shear mode is observed. This characteristic is represented by the presence of matrix debris being squeezed out between the fibers. This characteristic is referred to here as matrix hackles. The amount of matrix hackles present is minimal indicating that even though a shearing mode did exist, its contribution to final fracture was minimal and that the primary mode of fracture for this unidirectional laminate was a longitudinal tensile mode.

Figure 2 - Microstructural fracture surface characteristics of a notch/slit unidirectional G/E laminate. The dominant characteristics are the tiered and pulled-out fibers.

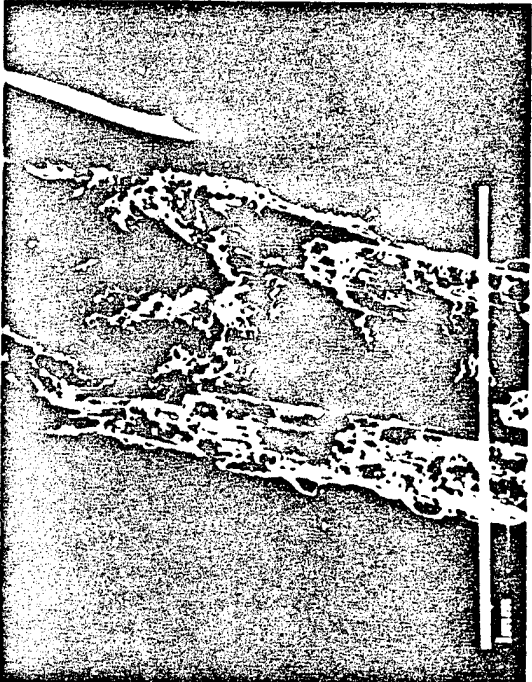
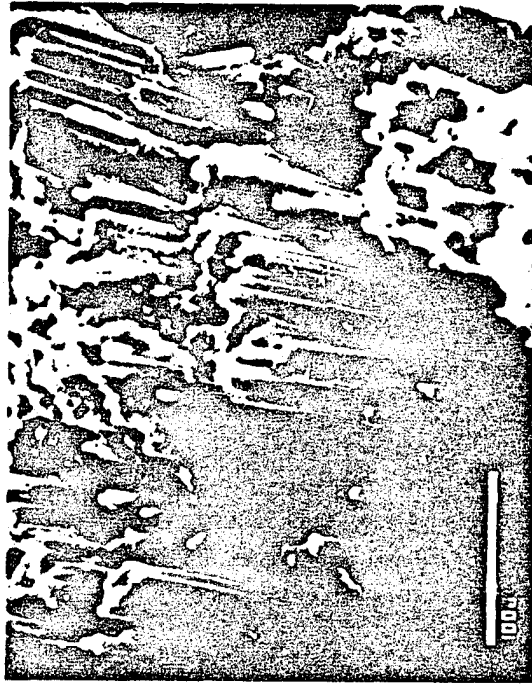
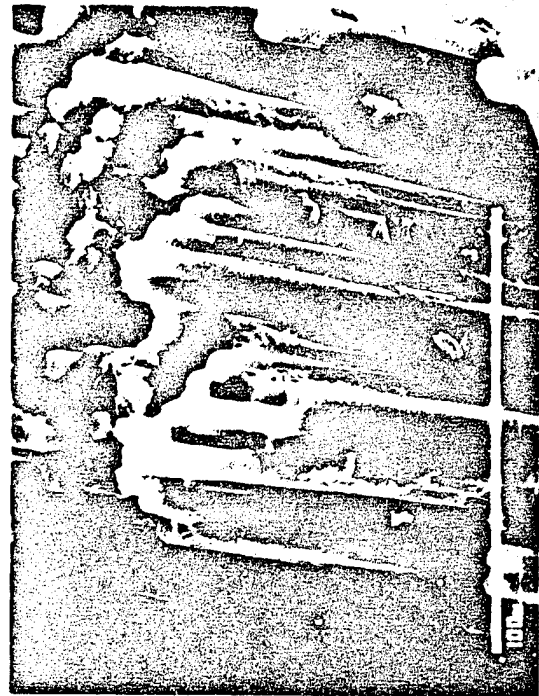
The same microstructural characteristics depicted for the unidirectional laminate are observed on the fracture surface of the  $[\pm 3]_s$  laminate (fig. 3). Although the characteristics are similar, there is a distinct change in the tier formation. Figures 3(a) and (b) show fiber pull-out and breakage occurring more randomly. This action still produces an irregular fracture surface but without the wall-like formation of each ply that existed for the unidirectional laminate. In figure 3(c), matrix hackles are apparent indicating an intraply shearing action. Nevertheless, final fracture was the result primarily of a longitudinal tensile fracture mode.

Figure 3. - Photomicrographs of the  $[+3]_s$  G/E laminate fracture surface. The predominant characteristic is the fiber breakage.

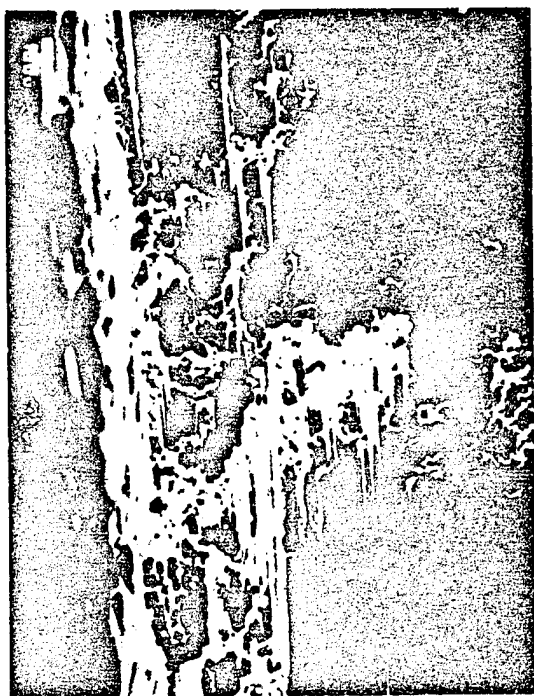
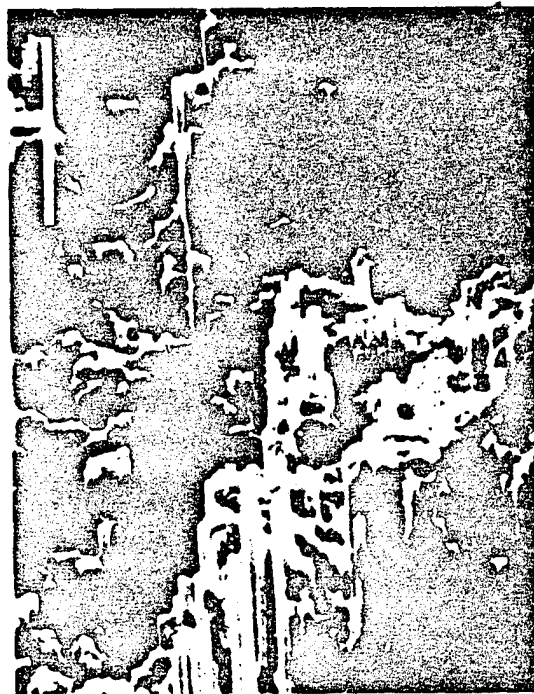
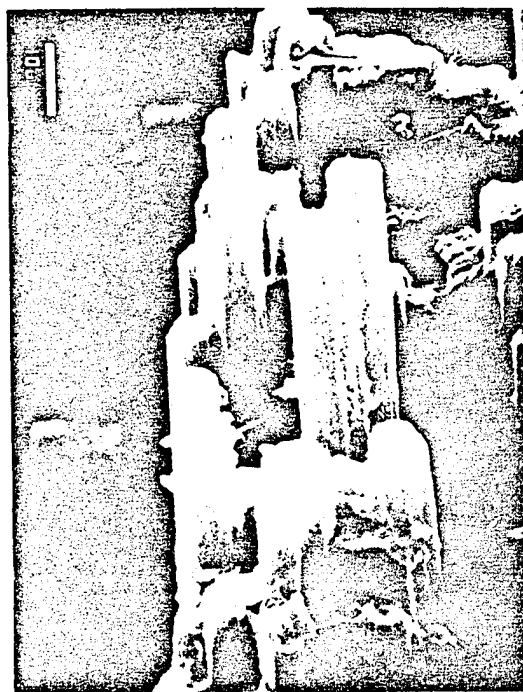
Fiber pull-out and breakage is the dominant trait of the  $[\pm 5]_s$  fracture surface displayed in figure 4. Although the surface is still irregular, individual fibers appear to be breaking at the same locations along the fiber resulting in a leveling-off effect. Matrix hackles are more evident suggesting that even though longitudinal tension is still the primary mode of fracture, intralaminar shear is becoming a larger contributor to final fracture.

Figure 4. - Microstructure of the fracture surface of the  $[\pm 5]_s$  G/E laminate revealing fiber breakage accompanied by matrix hackles.

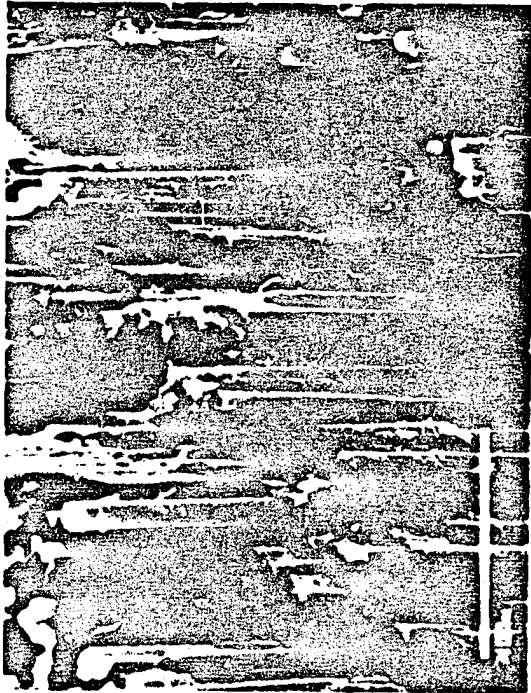
(a) 150X

Irregular fracture surface and fiber pull-out are still the outstanding microstructural characteristics for the  $[\pm 10]_s$  laminate exhibited in figure 5(a). The photomicrograph in figure 5(b), however, reveals a cluster of fibers with relatively clean surfaces breaking at approximately the same place indicating a combination of longitudinal tensile and intraply shear modes respectively. Figures 5(b) and (c) show matrix hackles appearing in an established pattern between the fibers instead of the random occurrence which was previously observed.

Figure 5. - The fracture surface of the notch/slit ( $\pm 10^\circ$ ) G/E laminate revealing matrix hackles between the fibers.

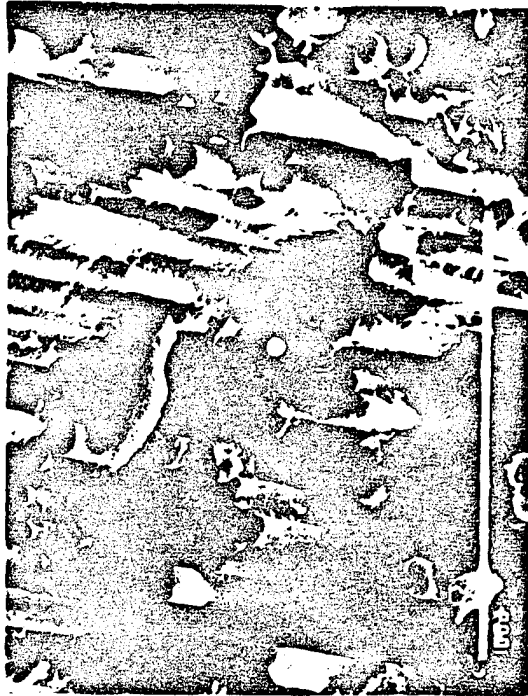
(b) 730X.

Photomicrographs of the  $[\pm 15]_s$  laminate fracture surface are presented in figure 6. The irregular surface (fig. 6(a)) and the clean fibers along with the fiber pull-out (fig. 6(b)) indicate a longitudinal tensile fracture mode. Figure 6(c) reveals not only an abundance of matrix hackles but also matrix debris on the surfaces of the fibers which are now forming a level surface, indicative of an intraply shear fracture mode.

Figure 6. - Photomicrographs revealing the microstructure of the [ $\pm 15$ ]s G/E fracture surface. Longitudinal tensile and intraply shear fracture modes are characterized by the fiber fracture and matrix hackles respectively.

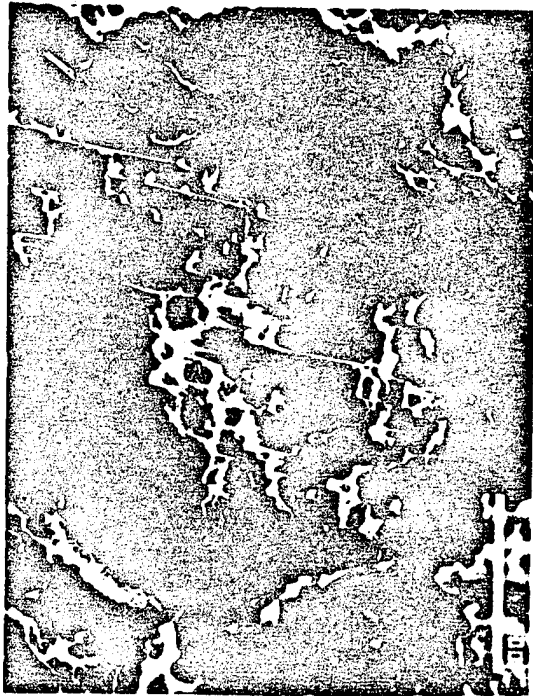
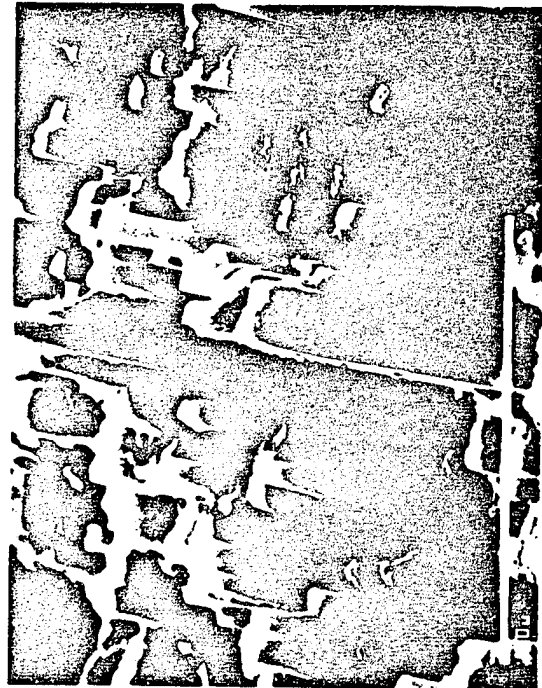
A significant change in the microstructure of the fracture surface is observed in the photomicrographs of the  $[\pm 30]_s$  laminate in figure 7. Fibers in the outer plies ( $+30$ ) are breaking at approximately the same place producing a level surface while the inner plies ( $-30$ ) are still experiencing fiber pull-out and breakage in different locations. The number of fibers affected by this longitudinal tensile fracture mode is decreasing (fig. 7(b)). At the same time, with the presence of matrix hackles and debris increasing (fig. 7(c)), it appears as though intraply shear is becoming the dominant mode of fracture as the ply angle orientation increases.

Figure 7. - Fracture surface characteristics of the  $[ \pm 30 ]_s$  notch/slit GIE specimen. The fibers broke at or near the same place producing a more level surface.

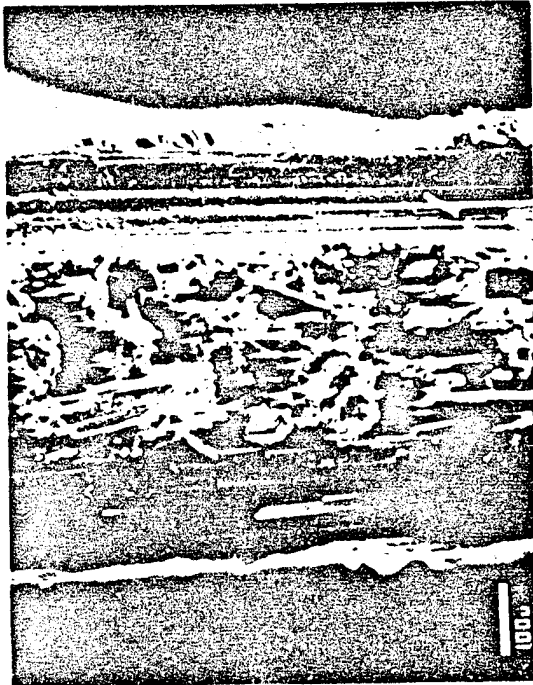
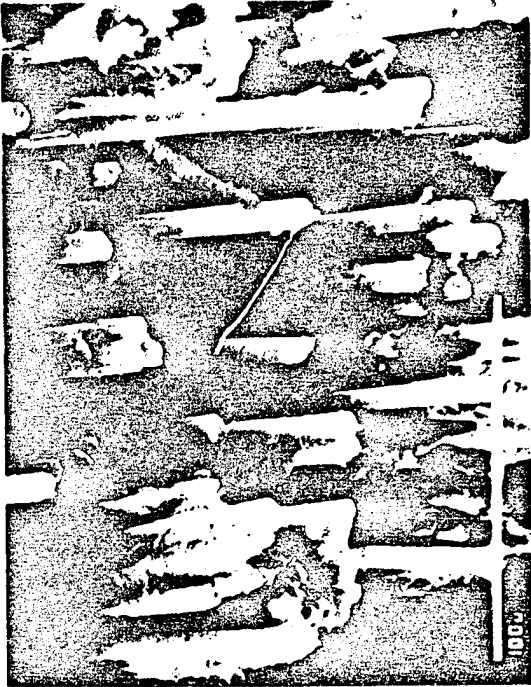
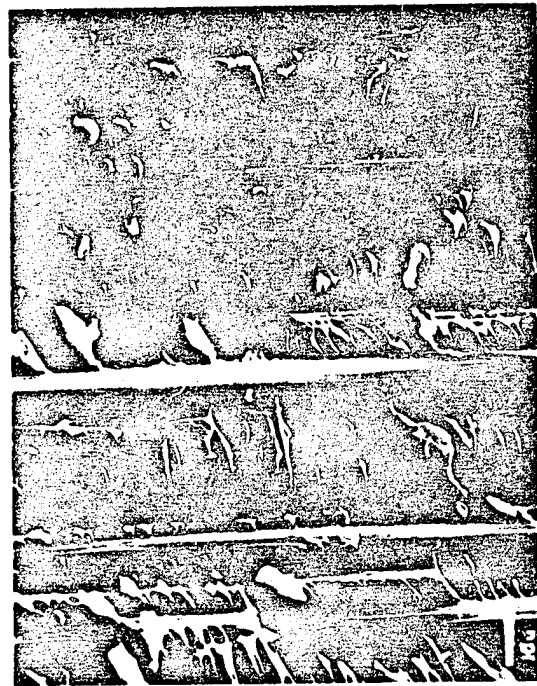
The prominence of intraply shear controlling the fracture process is illustrated in figure 8 which displays the fracture surface of the  $[\pm 45]_s$  laminate. The outer plies now consist of an entirely level surface. The distinct characteristic of the intralaminar shear mode is clean fiber surfaces surrounded by matrix hackles which is clearly depicted in the magnification of the outer level plies (fig. 8(c)). Figure 8(b) characterizes the longitudinal tensile fracture mode; however, the pulled-out fibers contain much matrix debris indicating the presence of an intraply shear fracture mode which is the primary cause of fracture for this laminate.

Figure 8. - Photomicrographs depicting the fracture characteristics of the  $[\pm 45]_s$  G/E laminate. Intralaminar shear fracture designated by matrix debris and hackles is the primary cause of final fracture.

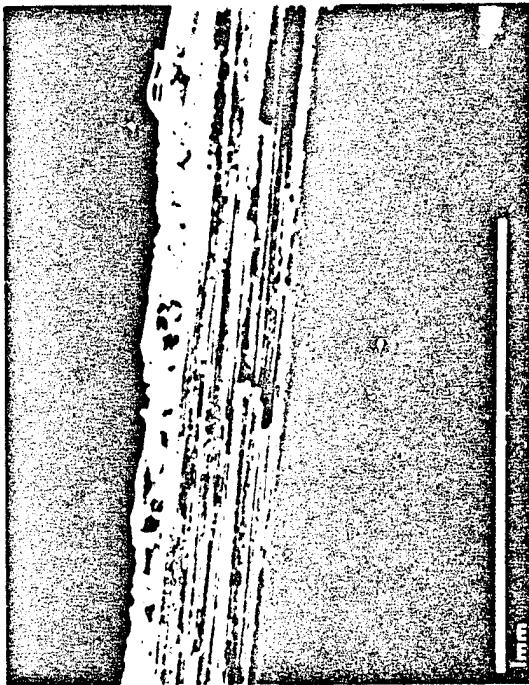
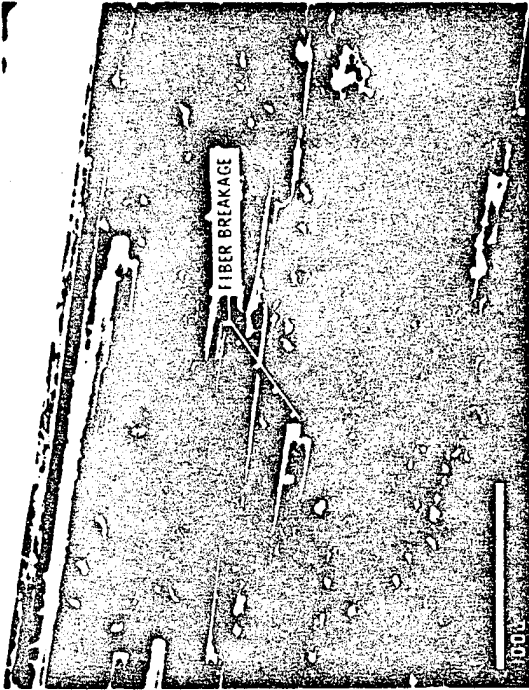
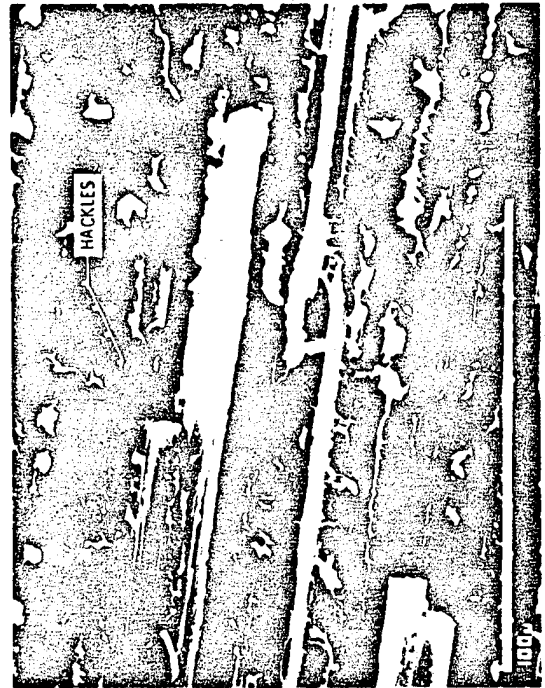
The fracture surface of the  $[\pm 60]_s$  G/E laminate in figure 9(a) is entirely flat with no sign of fiber pull-out. Some fiber breakage (fig. 9(b)) did occur but in the transverse direction. These microstructural characteristics are indicative of a transverse tensile fracture mode. The extensive presence of matrix hackles exhibited in figure 9(c) represents the intraply shear fracture mode which also induces final fracture in this laminate.

Figure 9. - Fracture surface characteristics of the [± 60] s GIE laminate. The flat surface is indicative of a transverse tensile mode of fracture.

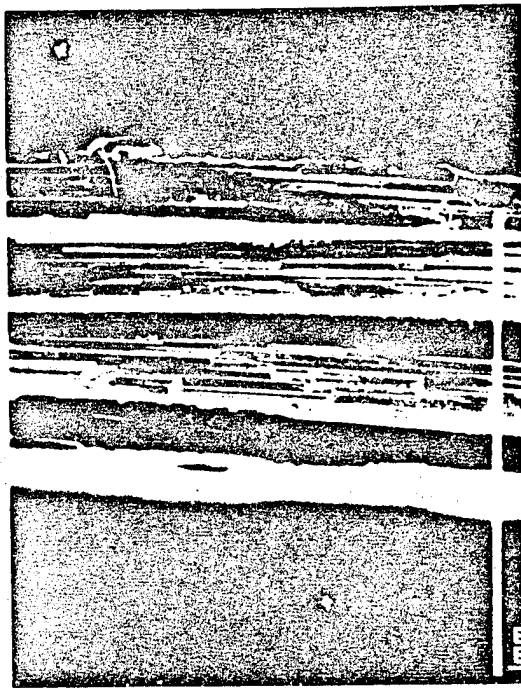
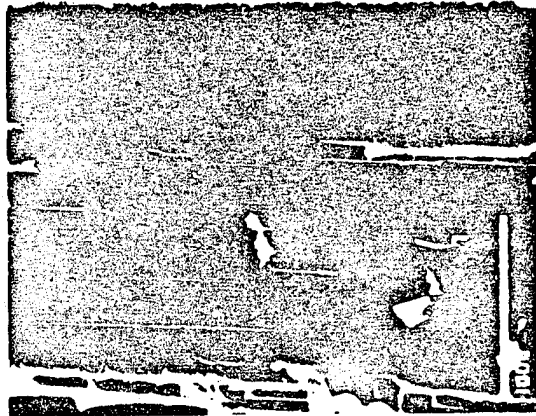
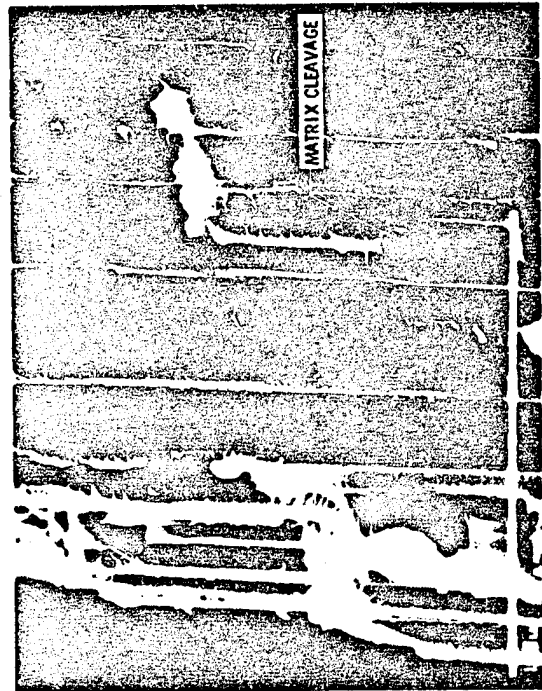
More fiber breakage occurring in the transverse direction on the flat fracture surface of the  $[\pm 75]_s$  laminate is shown in figures 10(a) and (b). A new characteristic, matrix cleavage, was observed on this surface and is illustrated in figure 10(c). Matrix cleavage resembles a cutting or hollowing-out of the matrix between relatively clean fibers. The microstructural characteristics of this laminate are the result of a transverse tensile fracture mode.

Figure 10. - In addition to the flat features, the [ $\pm 75^\circ$ ]s G/E fracture surface consists of fiber fracture and matrix cleavage.

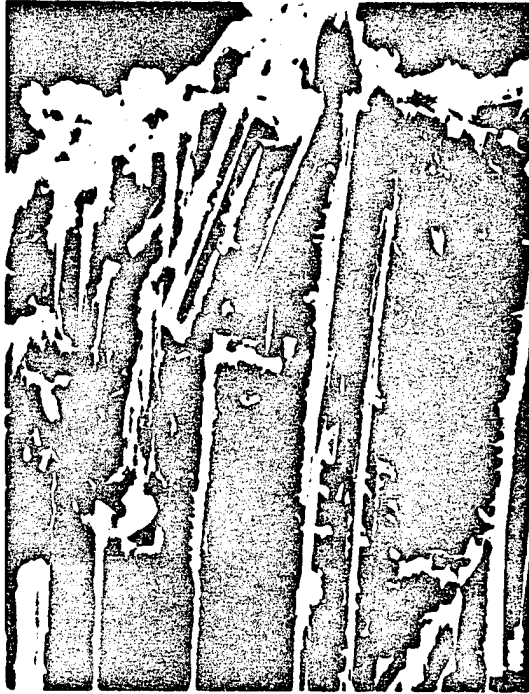
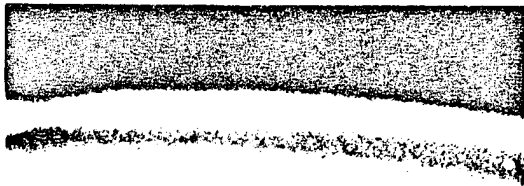
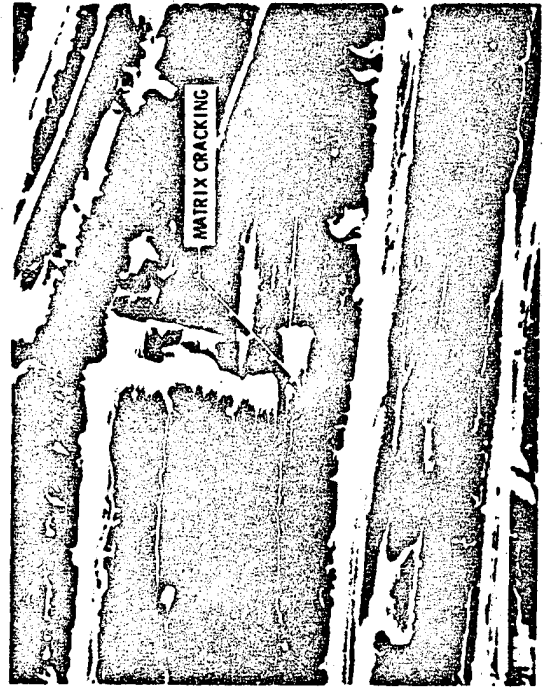
The final fracture surface to be examined is that of the  $[90]_4$  G/E laminate presented in figure 11. The flat fracture surface reveals some fiber breakage in figure 11(a). With the occurrence of extensive matrix cracking, the specimen is beginning to fall apart (fig. 11(b)). Magnification of the specimen's edge exposes the matrix cracking and cleavage which causes the fracture due to a transverse tensile fracture mode.

Figure 1L - The fracture surface of the notch/slit [90] G/E laminate consists of considerable matrix cleavage and cracking.

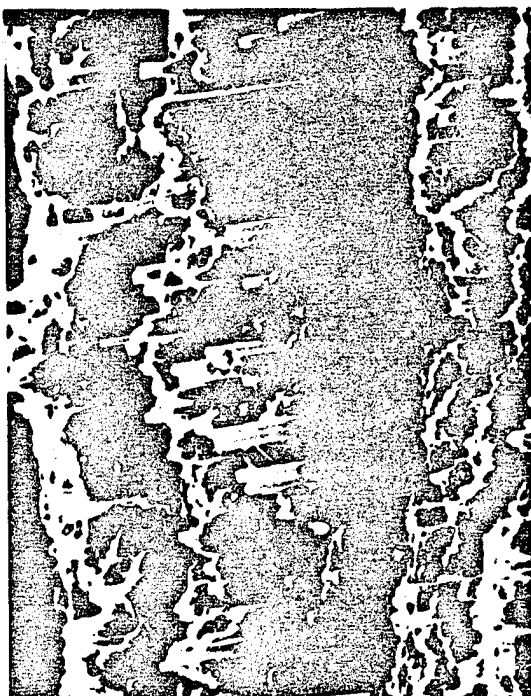
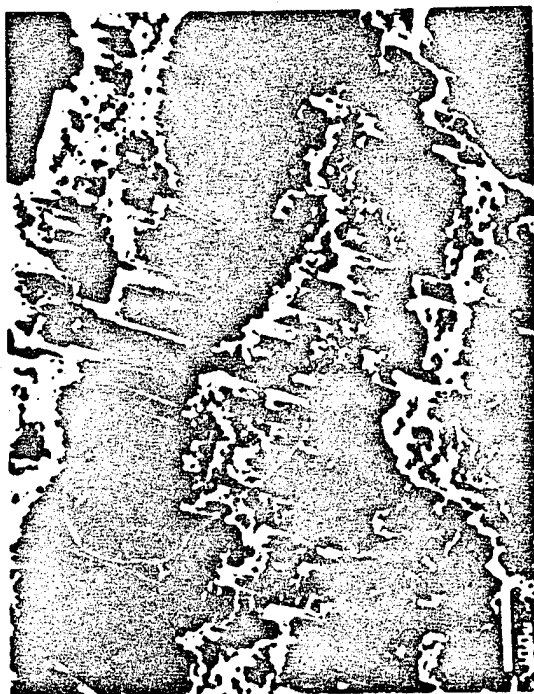
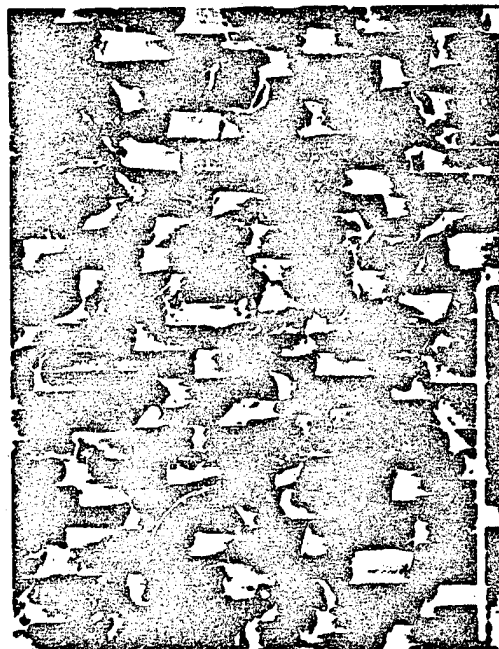
Through the microscopic analysis, it was revealed that neither the presence of a defect nor the type of defect had any effect on the fracture surface microstructural characteristics and thereby the fracture modes. This is illustrated in figure 13 for the unidirectional laminate and in figure 14 for the more complex fracture process of the  $[\pm 45]_s$  angleply laminate. As can be seen, the microstructural characteristics are identical for the solid and notched specimens for each laminate. This phenomenon was also present in the CODSTRAN predictions which are listed in table IV. Results for the unidirectional and  $[\pm 45]_s$  laminates, as well as all the other laminates, indicate that neither the presence of a defect nor the type of defect affect the primary mode of fracture in these G/E  $[\pm \theta]_s$  laminates. Therefore, use of the fracture surface of the notch/slit laminate to represent the microstructural characteristics of a particular laminate is valid.

Figure 13. - The microstructural fracture surface characteristics of the unidirectional G/E laminate.

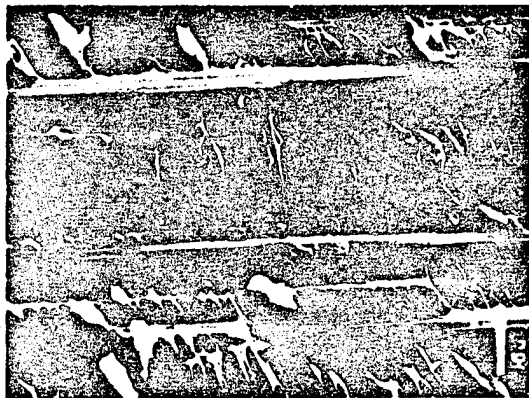
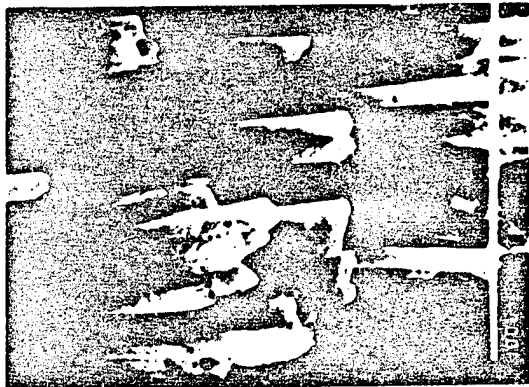
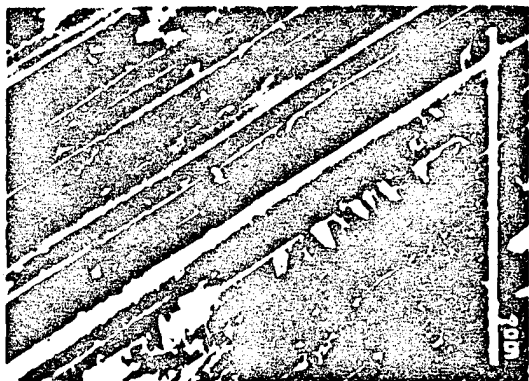
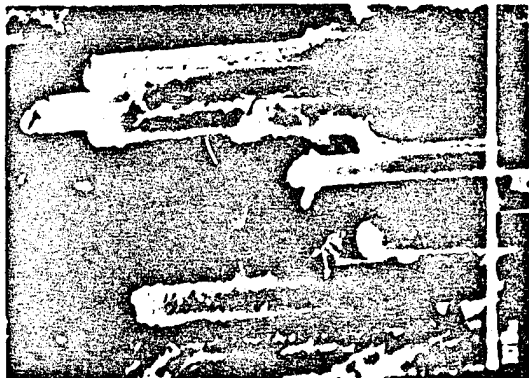
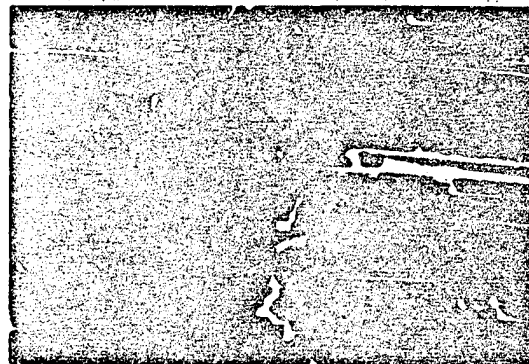
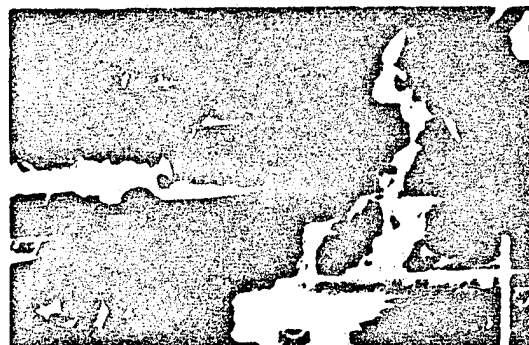
Figure 14. - Fracture surface characteristics of the  $\epsilon_2$  45° G/E laminate.
